# Manhole Inspection Summary

Manhole # S55I\_\_004MH

**Location** Address: **400 s conkling st**

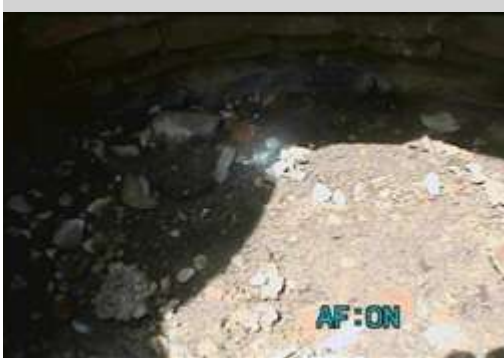
Defect 2

Condition: ☐ Sound ☐ Cracked ☐ Root Intrusion ☐ Deteriorated ☐ Leaks ☒ **Debris**

bench debris

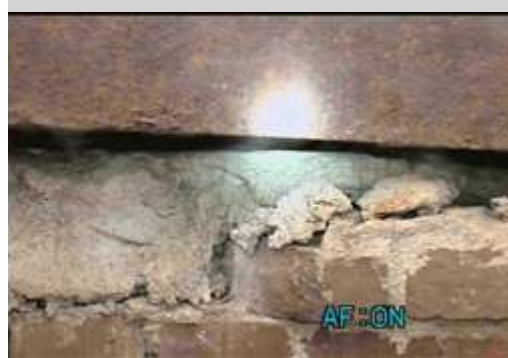
Defect 1

Condition: ☐ Sound ☒ **Cracked** ☐ Root Intrusion ☒ **Loose Brick** ☐ Deteriorated

chimney cracked and loose bricks, frame adj

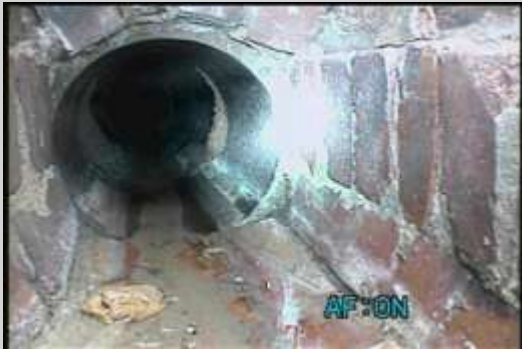
12 O'Clock Outflow

8 in. Circular Gravity Sewer  
Pipe Out @ 12 O'Clock

Invert Depth: 3.13 (ft.) Flow Characteristics: **Slow**

Deposits: ☒ None ☐ Mud ☐ Sludge ☐ Debris ☐ Grease

Infiltration: **None** Pipe Seal Cond: **Unknown**

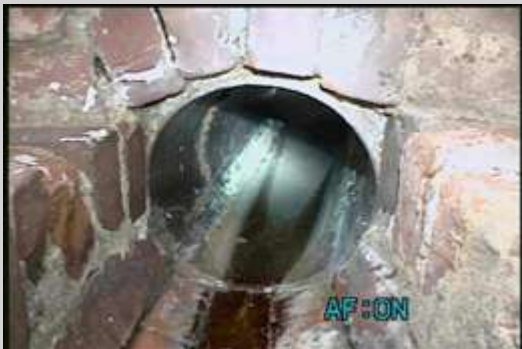
9 O'Clock Inflow

8 in. Circular Gravity Sewer  
Pipe In @ 9 O'Clock

Invert Depth: 3.00 (ft.) Flow Characteristics: **Fast**

Deposits: ☒ None ☐ Mud ☐ Sludge ☐ Debris ☐ Grease

Infiltration: **None** Pipe Seal Cond: **Unknown**
